Oxygen Pitting of Boiler Tubes has always been a Problem

Oxygen Corrosion in Boilers

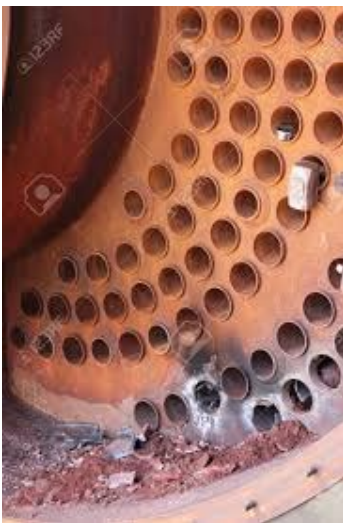
Firetube Boilers Designed with Replaceable Tubes

Leaking Firetube Boiler

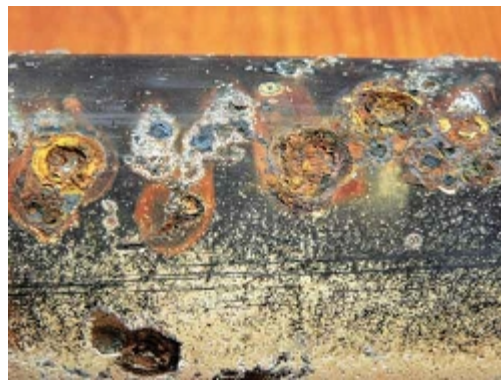
Oxygen Pitting Requiring
Tube Replacement

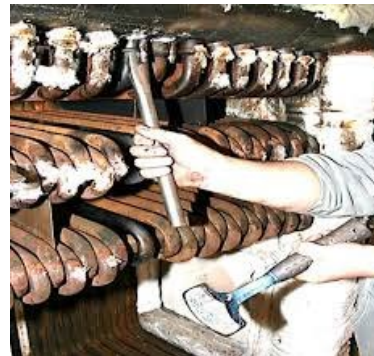
Replaceable Flex Tube
